**AFFIDAVIT OF PROBABLE CAUSE FOR ARREST WARRANT**

Asbestos Remediation and Abatement:

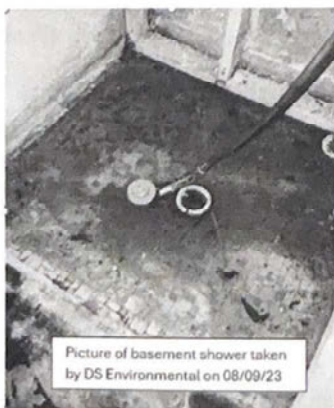
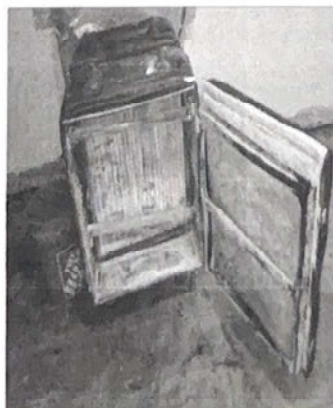
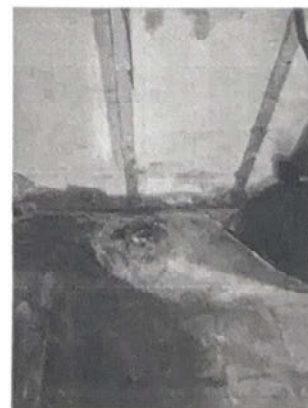
Mrs. Rux also described what she observed after Mr. Roberts represented he had finished the clean up. Mrs. Rux described how she found debris inside her washer and dryer, standing water filled with debris in the non-functioning shower pan, and even a very dirty air filter Mr. Roberts had left behind.

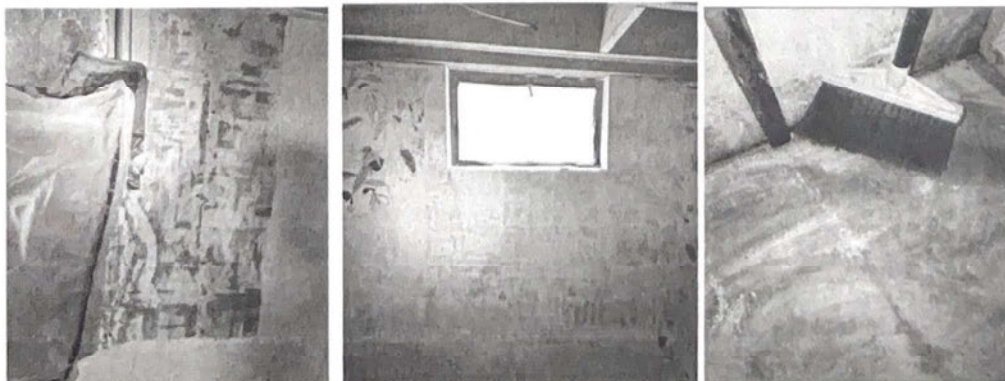
The nature of the building material dictates the removal method, and the care taken during the work can make the impact more or less significant. Using tools such as hammers or crowbars as referenced in the permit application to remove the drywall ceiling could cause significant impact and disturbance of ACM. Mr. Burns noted that most professionals usually attempt to remove larger chunks at the time to generate less debris. By looking at the pictures, Mr. Burns can see marks around the windows that are indicative that some sort of a blade or scraping tool was used, which would be a very impactful removal method. Mr. Burns explained that everyone can live safely around asbestos as long as it remains undisturbed but by scraping around the windows, Mr. Roberts impacted every square inch of the building matrix with his removal activities.

Mr. Burns reviewed the delineation report from August 2023 and noted that he could see incomplete removal of ACM, sweep marks, debris, and again remarked about the scrape marks around the windows. Mr. Burns explained that according to asbestos inspection report, the ACM

that needed to be abated around the windows was located in a compound layer that is used to help the paint adhere better to the concrete. This compound is applied directly to the concrete and imbedded deep into the pores. From Mr. Burns' experience, abating this compound requires extensive work using aggressive methods to get it out of the concrete pores, such as sandblasting. Scraping the compound would not be an adequate removal method at all as it would be completely ineffective but would also release asbestos.
